WC22 - Replacing Camshaft Controller (Workshop Campaign)

Model Year: **2011**

Vehicle Type: **Cayenne S (92A)/Cayenne Turbo (92A)**

Concerns: **Camshaft controller**

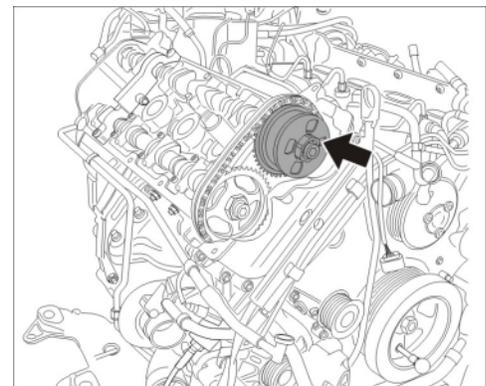
Camshaft controller

Due to a temporary screw connection assembly problem, existing threaded connections on the camshaft controller can become strained to such an extent that the function of the camshaft controller cannot be guaranteed over the service life of the vehicle.

Attachment "A": 1 **Remove both camshaft controllers** as described in the **Workshop Manual** ⇒ *Workshop Manual '158419 Removing and installing camshaft controller - section on "Removing"*.

- 2 **Install new** camshaft controllers, Part No. **000.043.207.88**, on **cylinder bank 1 and 2** ⇒ *Workshop Manual '158419 Removing and installing camshaft controller - section on "Installing"*.
- 3 Enter the workshop campaign in the Warranty and Maintenance booklet.
